An original Approach to Retrofitting A Post and Core Restoration to an Existing bridge

Citation: Debbabi Imen, Saafi Jilani, Nouria Zohra, Harzallah Belhassen, Cherif Mounir (2018) An original Approach to Retrofitting- A Post and Core Restoration to an Existing bridge. J Oral Health Dent Sci 2: 202

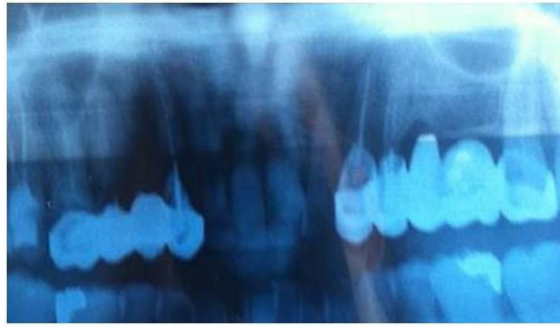
Figure 1: Panoramic radiography

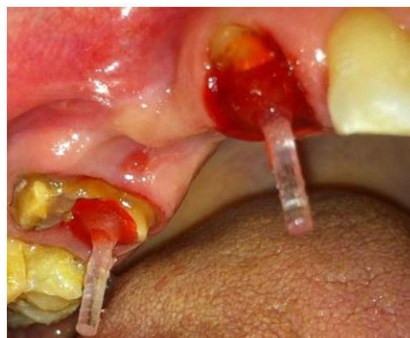
Figure 7: The plastic posts were rebazed with duralay resin

The healing of the gum related to the socket was well improved. After selecting an appropriate size of plastic posts (Para-Post, Whaledent International, New York, N.Y.), they were inserted into the prepared root canals. The plastic posts were rebazed by Coating the post with an autopolymerizing acrylic resin material (Duralay, Reliance Dental Mfg Co, Alsip, Ill.) to ensure better adaptation to the teeth structure (post in post space of #13 and the palatal post space of the #16) (Figure 7). The length of the post were adjusted by cutting them with a disk so they do not interfere with the inner surfaces of the retainers which can jeopardize accurate seating and appropriate occlusion (Figure 8).

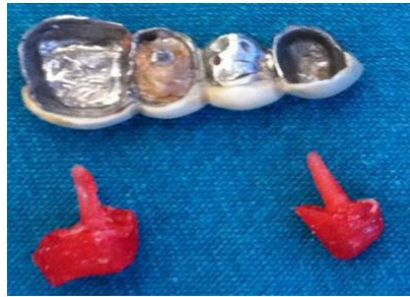
Figure 12: Old bridge with two models of two duralay posts and cores

The refabricated Duralay posts and cores were checked so that there was no deficiency of the material and that the contour of the previous cast post and core was reproduced and excessive core material may remain over the margin was removed using a probe. The setting time of the Duralay resin is 5 min. the models of 2 posts and cores were refined using dental diamond bur on turbine under irrigation to create additional cement space between the abutments and the retainers, then sent to the laboratory to be casted in metal (Figure 11,12 and 13) [5]. Obviously at this step adding grooves or boxes to the refabricated duralay post and core (new abutments) limits the paths of placement, so retention is increased [9].
